# Method of Railway Subgrade Diseases (defects) Inspection, based on Ground Penetrating Radar

## Yaonan Li[1], Hengbai Liu[1], Shilei Wang[1], Bo Jiang[1], Szabolcs Fischer[2]

[1]Infrastructure Inspection Research Institute, China Academy of Railway Sciences Corporation Limited, Beijing, China, 100081
[2]Széchenyi István University, Egyetem tér 1, H-9026 Győr, Hungary
e-mail: liyaonan@rails.cn, liuhengbai@rails.cn, wangshilei@rails.cn, pjiang@rails.cn, fischersz@sze.hu

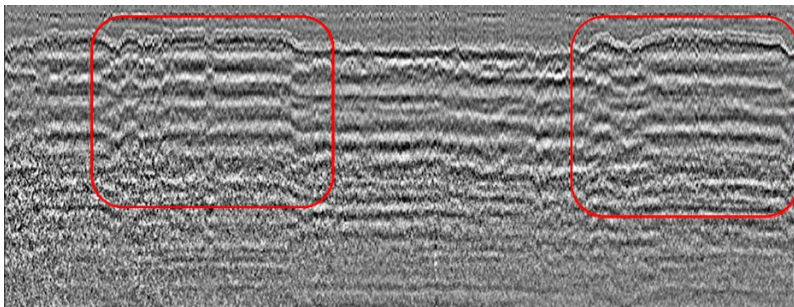
Figure 6

(1) The radar image of mud pumping is characterized by continuous flat or undulating strong reflection coaxial axis in the depth range from the ballast bed surface to the subgrade bed surface. Differences in water containing conditions might result in the differences in multiple reflections, and cover the signals reflected from the interfaces of ballast bed and subgrade bed. What's worse, the illusion that the interface of ballast bed and subgrade bed uplifts towards the shallow layer might occur. The distance between the top surface of mud pumping and the top surface of the Rail Sleeper is limited to 25 cm. Mud pumping is further divided into concealed mud pumping (surface depth is less than 25 cm) and exposed mud pumping (surface depth is greater than 25 cm).

Radar image features of mud pumping

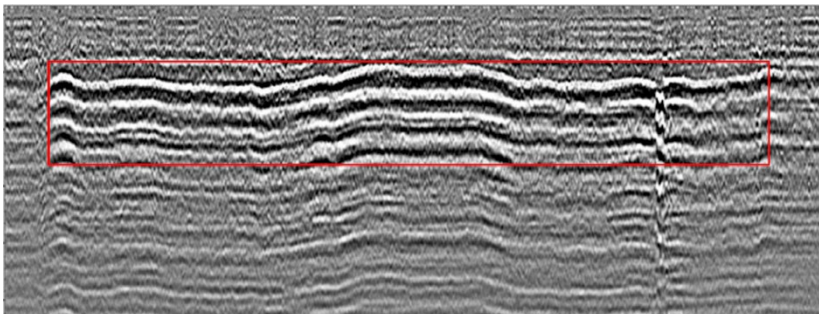
(2) The high water content of the subgrade or foundation might lead to the subgrade quality deterioration and instability, and further cause diseases such as mud pumping and subsidence. The image features of water accumulation are characterized by low frequency strong reflection, large amplitude, reverse phase and multiple reflections at the interface, and the interface is relatively flat.

Figure 7
Radar image features of water accumulation along the line

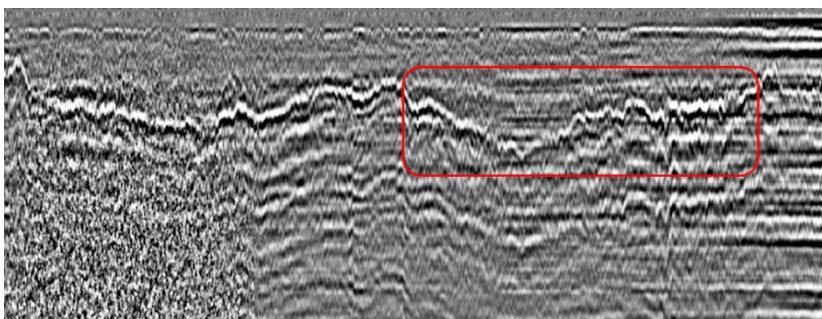
Subsidence refers to the local or relatively large vertical settlement or subsidence deformation under the coupling effect of water, overlying load, self-weight, climate change, dynamic train load and vibration resulting from insufficient compactness of the ballast bed, subgrade, or foundation. It is also called ballast pit, ballast sack or ballast pocket in case of local or small range with the ballast trapped in the subgrade bed. Radar image features of subsidence area as follows: The reflective events of the interface between the ballast bed and the subgrade bed structure, and between the subgrade bed surface and the substratum indicate significant bending, discontinuity or offset of the depth downwards. By the length limit of 10 m, the subsidence diseases are further divided into ballast trap (with a length of less than 10 m) and structural interface fluctuation (with a length of greater than 10 m). The subsidence is identified mainly through one-off inspection, which represents the condition of subgrade at the time of inspection. In contrast, multiple inspections are required for judging the subsequent development trend of subsidence.

Figure 8
Radar image features of subsidence

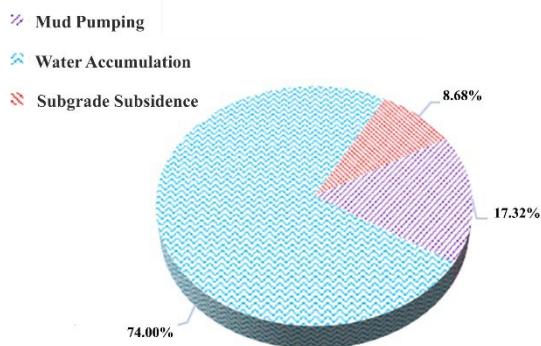
Figure 9

The distribution and proportions of various subgrade diseases are shown in Fig. 9. Specifically, by the ratio between cumulative length and total length, mud pumping, water accumulation and subsidence accounted 17.32%, 74.00%, and 8.68%, respectively.

Distribution of subgrade diseases

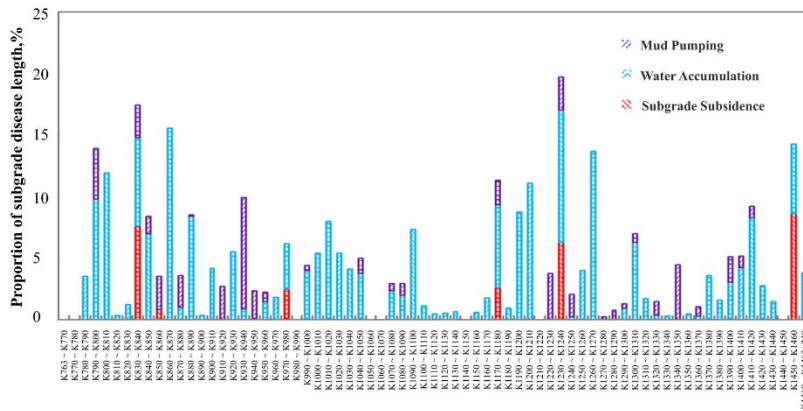
Figure 10

Statistical analysis was made based on the cumulative length of diseases in the 10 km interval. The results show that the cumulative length of subgrade diseases in the K1230-K1240 segment accounted for 19.70% of the total subgrade length of this segment.

Distribution of diseases along the route

Analysis of inspection data is makes it possible to understand the distribution of three typical diseases by line length (Figure 10) and depth. In particular, it is useful for accurately judging whether mud pumping has occurred inside the ballast bed. In addition, the railway maintenance unit can optimize the ballast bed screening plan according to the distribution of diseases by depth. In order to ensure the long-term effect of ballast bed screening, the key subgrade diseases can be treated together.

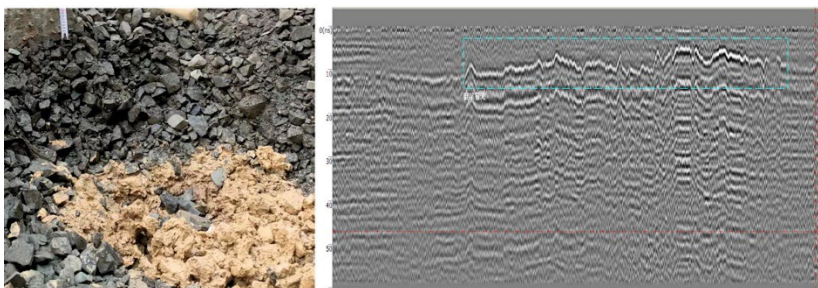
Excavation and verification results of mud pumping disease along the K920+800 line

Figure 11 shows the excavation and verification results of mud pumping disease along the K920+800 line. Radar reflection waveform shows the characteristics of uneven reflections, there are multiple reflections in the underlying layer, and the

mud pumping interface has not reached the surface layer. Therefore, it is deemed as concealed mud pumping. Site excavation findings are consistent with the inspection conclusions. Obvious mud pumping was seen after excavation without access to the rail surface.

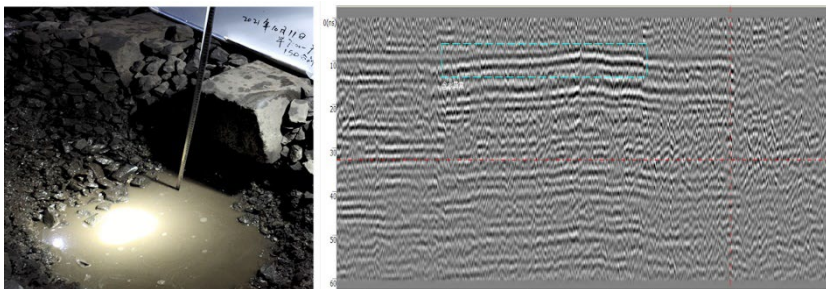
Figure 12
The result of water accumulation test of K1253+400 line

Figure 12 shows the excavation and verification results of water accumulation along the K1253+400 line. The radar reflection waveform in Figure 12 shows parallel strong reflection characteristics, and there are multiple reflections in the underlying layer, Therefore, the line is deemed as water accumulation. Site excavation findings are consistent with the inspection conclusions, and obvious water accumulation was seen after excavation.
